### **USAAMRDL TECHNICAL REPORT 72-19**

OIL-STARVATION TEST PROGRAM:
EVALUATION OF VASCO-X2 STEEL SPIRAL BEVEL GEARS

FINAL REPORT

CONTRACT DAAJ02-72-C-0009
THE BOEING COMPANY, VERTOL DIVISION
PHILADELPHIA, PENNSYLVANIA

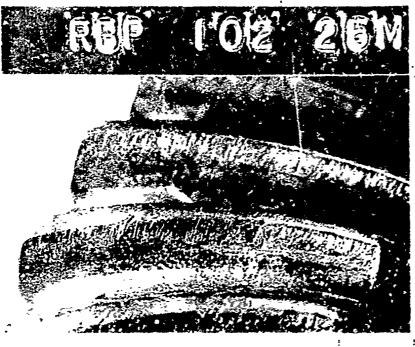
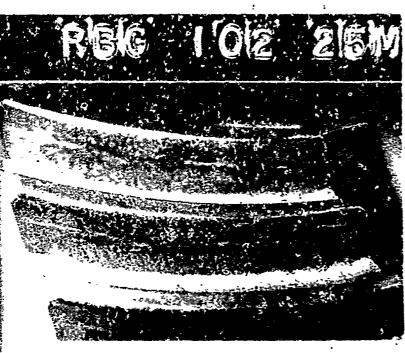
# BASELINE GEAR SET 1

Baseline Gear Set Number 1 - At the end of the run-in tests, the temperature gages were not exposed. After 20 minutes of non-lubrication testing, the vibration signal grew to approximately four times the signal seen at the start of the test run, and the test was ended. The rapid growth in vibration signal occurred in a very short time (seconds), indicating the need for constant visual surveillance of the oscilloscope. Visual inspection of the gear tooth surfaces at the end of nonlubrication testing revealed severe scoring and metal flow, heat discoloration, and pitchline pitting, but no cracks. Metal was transferred from the tips of the teeth on the drive side and

deposited in the fillet root in the form of a metal fin on practically every tooth of the pinion member. The gear member was also heavily scored, but to a somewhat lesser degree than the pinion, with heavy wear indications at the toe end of the driven side. A great deal of metal debris was found in the test housing. This debris was in the form of slivers and splinters. The connecting cross-shaft to the slave beyel gearbox developed heat color stains of 'ight blue, violet, brown, and amber, in that order, coming away from the test gear mesh. Heat stains of comparable colors on 4340 steel (the shaft material) usually indicate a temperature of 650°F to 750°F.

Disassembly of the test pinion was difficult due to ovality of the mounting holes. In addition, several areas indicated the initial stage of welding the bolts to the mounting holes.

The evidence of metal flow on the pinion gear teeth is a good indication that the temperature experienced by the pinion blank was in excess of 1000°F. The temperature gages were missing from the pinion and found in the test housing. All of the temperature dots on the sensor plates had turned black.

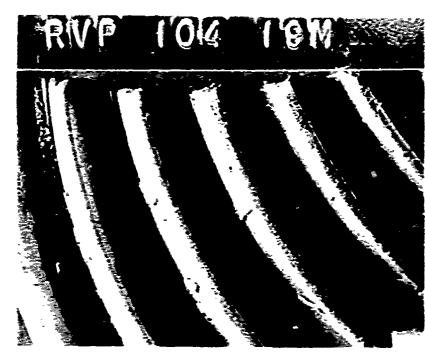
Figure 17 - Continued (Sheet 2 of 3).

VASCO-X2 GEAR SET

Pinion Number Al04

Pinion Number Al

Gear Number Al06
